**National Register of Historic Places  
Registration Form**

historic name Brick House Farm

other names CAR-15; Benjamin's Lott; Richard Jarrell Farm; Ernest Bowman Farm

Brick House Farm (CAR-15)  
Name of Property

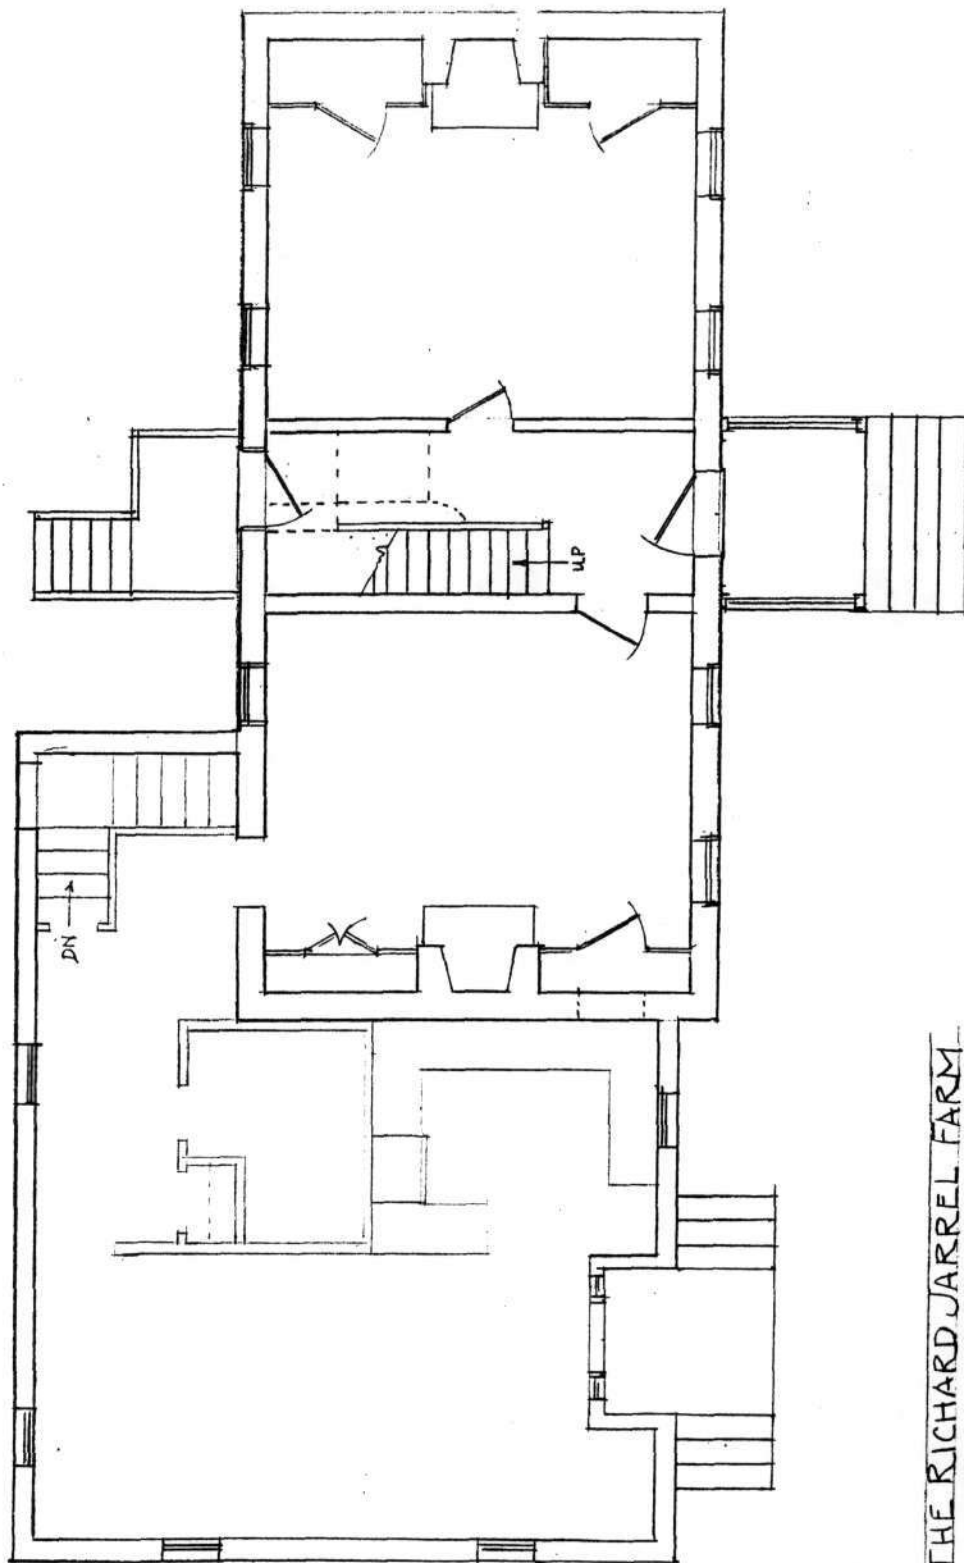
THE RICHARD JARREL FARM  
FIRST FLOOR PLAN  
SCALE -  $\frac{3}{8}'' = 1'-0''$   
18 MARCH 2008 - M BOURNE

As can be surmised from the exterior, the plan of the Jarrell Farmhouse is a typical "I-house" plan, with central stair passage and one room on each side. The right or east room is the parlor and the left or west room is the dining room. The kitchen is on the west end of the main block and has a plan all its own which will be described below.

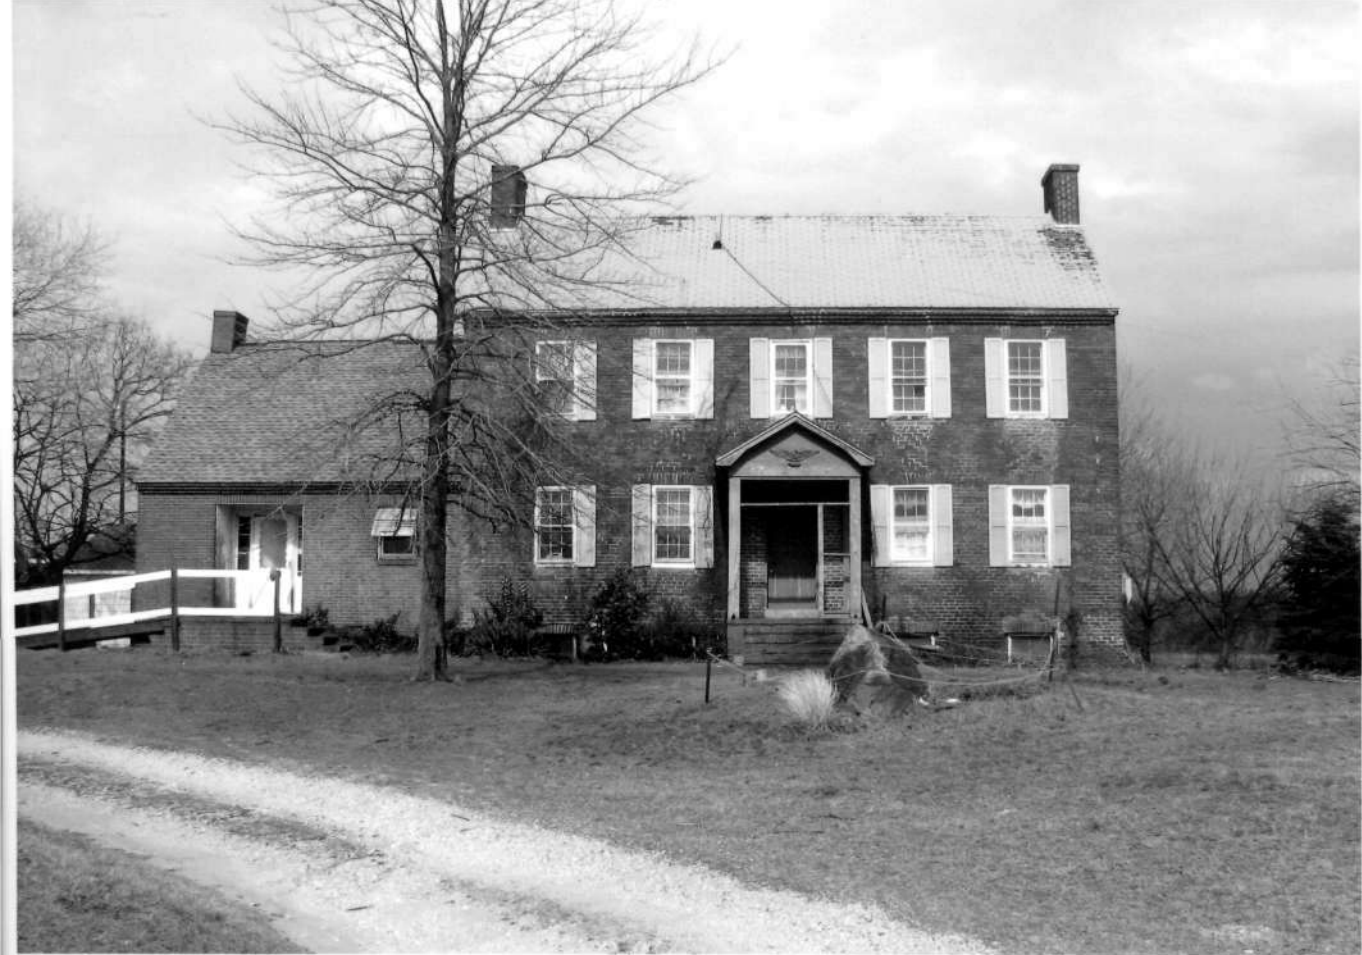
0001

SOUTH FACADE

Common bond brickwork (five courses of stretchers to one of headers) was used on all sides of the main block except the all header corbelled cornice. There is neither water table nor belt course, the change of wall thickness being concealed within. There are short basement windows with one-brick-high jack arches that do not retain original frames however the windows on the first and second stories above retain original frames, 9/6 sashes and jack arches the same height as those in the basement windows. Fiberglass shutters are from a remodeling in the late 20<sup>th</sup> century. The windows were originally made for shutters or blinds as there are two shutter dogs remaining on the north wall as well as holes in the mortar where the others were located. Centered on the façade is a 1970s porch with brick floor and steps that appears to have replaced an earlier one of approximately the same size. It protects the original door and paneled jambs that rest on a stone sill. The recessed panel door has six panels that align with the paneled jambs while the 4-pane transom aligns with the uppermost panels of the jambs.

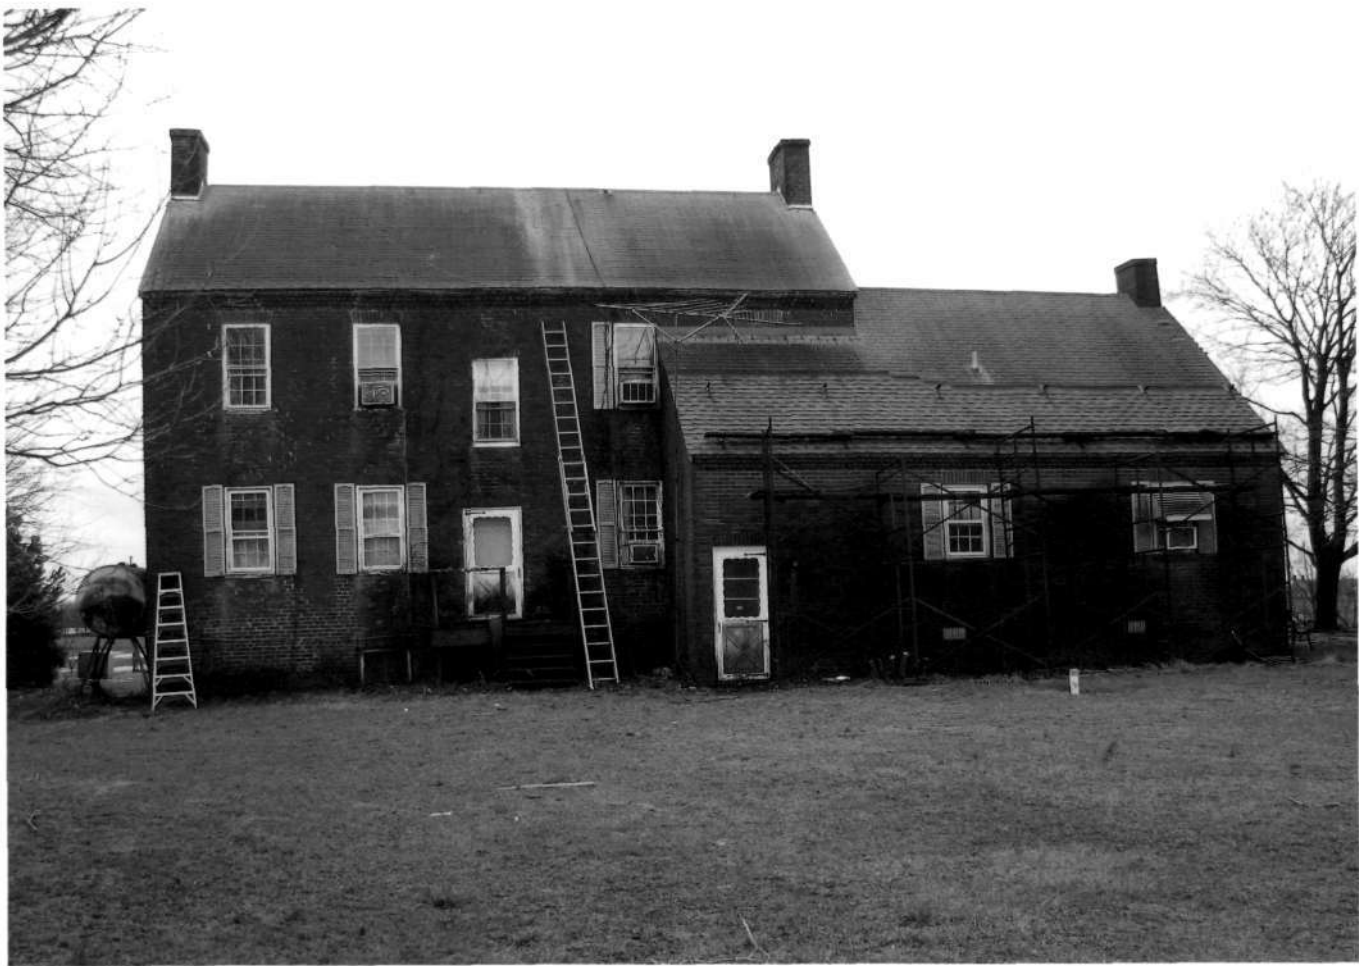
0004

NORTH FACADE

The north façade was originally five bays long but the kitchen wing overlaps the westernmost bay on both stories. On this façade only one basement window remains below the east window closest the central door.

The other basement window was located below the westernmost window and it was lengthened to serve as the basement entrance from the kitchen wing. Nearly centered on the original façade is an original six panel back door without a transom. Like the front door it has recessed panels as do the paneled jambs and head. A makeshift back stoop extends from the back door giving access from the first floor to grade. Centered above the back door is a window at stair landing level while the other second story windows with 9/6-pane sashes are higher in the wall.

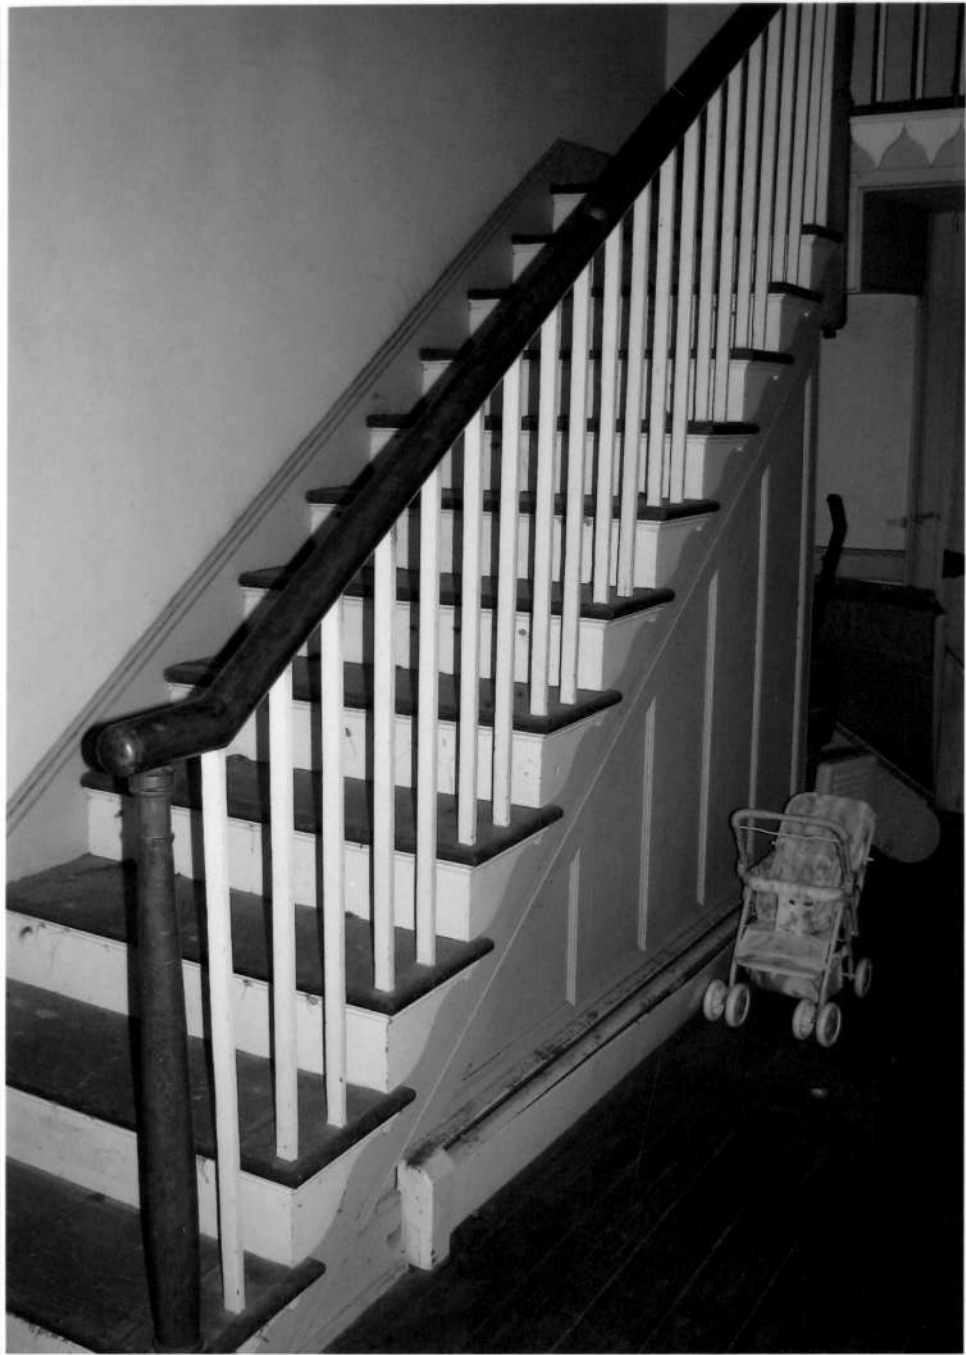
BRICK HOUSE FARM (CAR-15)  
CAROLINE Co., MD  
MICHAEL BOURNE  
MARCH 2008  
CENTRAL STAIR,  
VIEW N.W.  
0005

Two original exterior doors open into the stair hall whose principal feature is the open string stair on the west side of the hall with turned newels and rectangular balusters, two per step, with nearly round handrail

having goose neck ramps above the newels. The handrails from the second story to the attic are straight without ramps that extend from newel to newel. There is a recessed panel spandrel composed of five vertical panels. Above the panels are simply shaped ogee step ends. The spandrel wall stops beneath the landing newel post and from there to the north and west walls, it is an open part of the hall. A closet door is frequently located where the paneled spandrel stops but in this instance there is none. Instead a short two-panel closet door is located about two feet under the stair. It provides very little storage space, however this arrangement enables the back door to be centered beneath the stair landing. An unusual feature of the landing is a series of applied decorative features each with symmetrical ogee curves similar in shape to a drop finial. Original two-piece chair rail remains in place in the hall along with beaded baseboard. Besides the exterior doors there are two other doors opening into the east and west rooms, the east door described with the parlor being centered on the wall and the west door being south of the stair that opens into the west room (dining room).

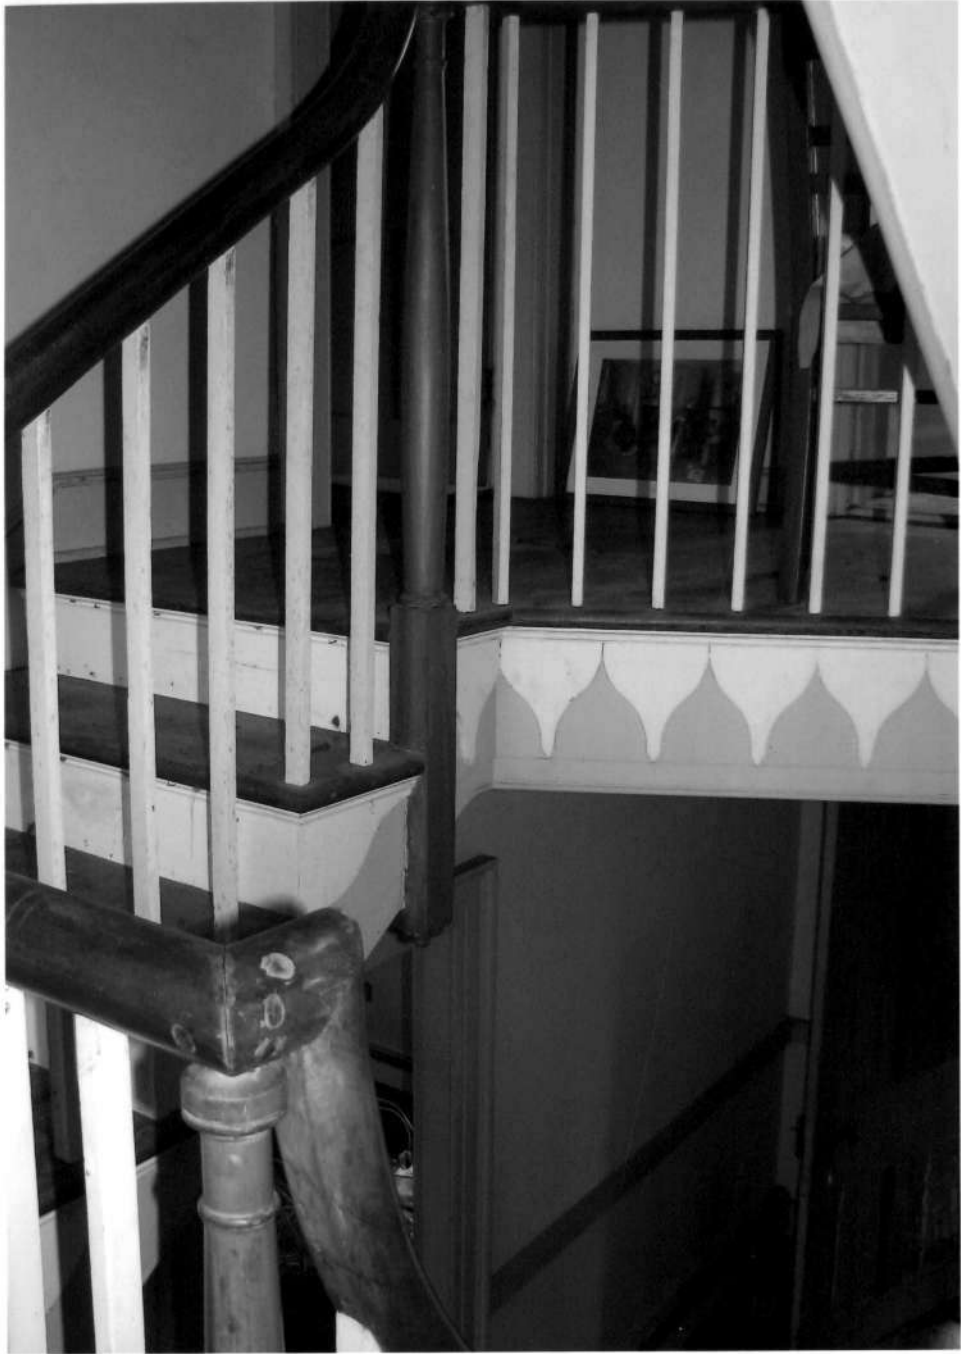
0012

VIEW OF BALUSTRADE FROM LANDING  
TO Southeast

Ascending the central stair in a northerly direction there is a two level landing above the back door from whence the stair continues in a southerly direction until it reaches the second floor. At the top of the stair the handrail turns an oblique angle toward the attic stair newel. The floor follows the same angle. At the head of the stair is a small room with board wall and a board & batten door having a small hinged opening in the top thereof, the reason for which is probably to light the hall when all doors are closed. The age of the partition is questionable as it is relatively crude in comparison to the finish in the rest of the house. Within the space is the

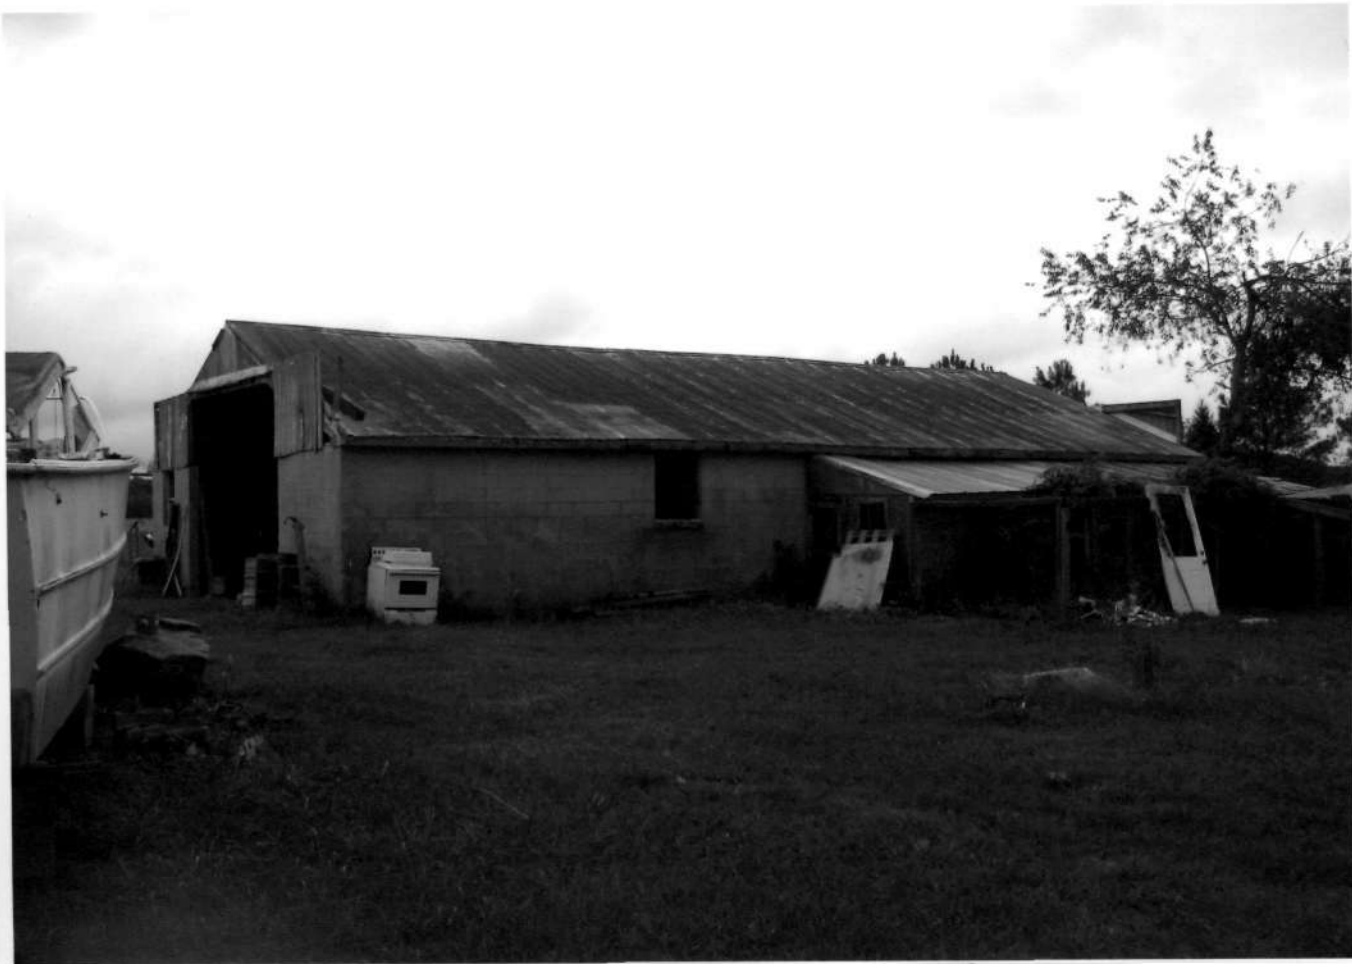
0023

VIEW OF MECHANICAL SITED  
FROM THE EAST

Beyond the former garage is a larger rectangular concrete block structure with both north and south gable ends open to the outside. It was constructed as maintenance shed for farm machinery. There were sliding doors at both open ends the track of which is higher than the adjoining block walls. There are four steel frame windows, one on the south, two on the west and one on the east. At the northern end of the east wall is a frame lean-to addition. The roof is covered with rusty corrugated metal.

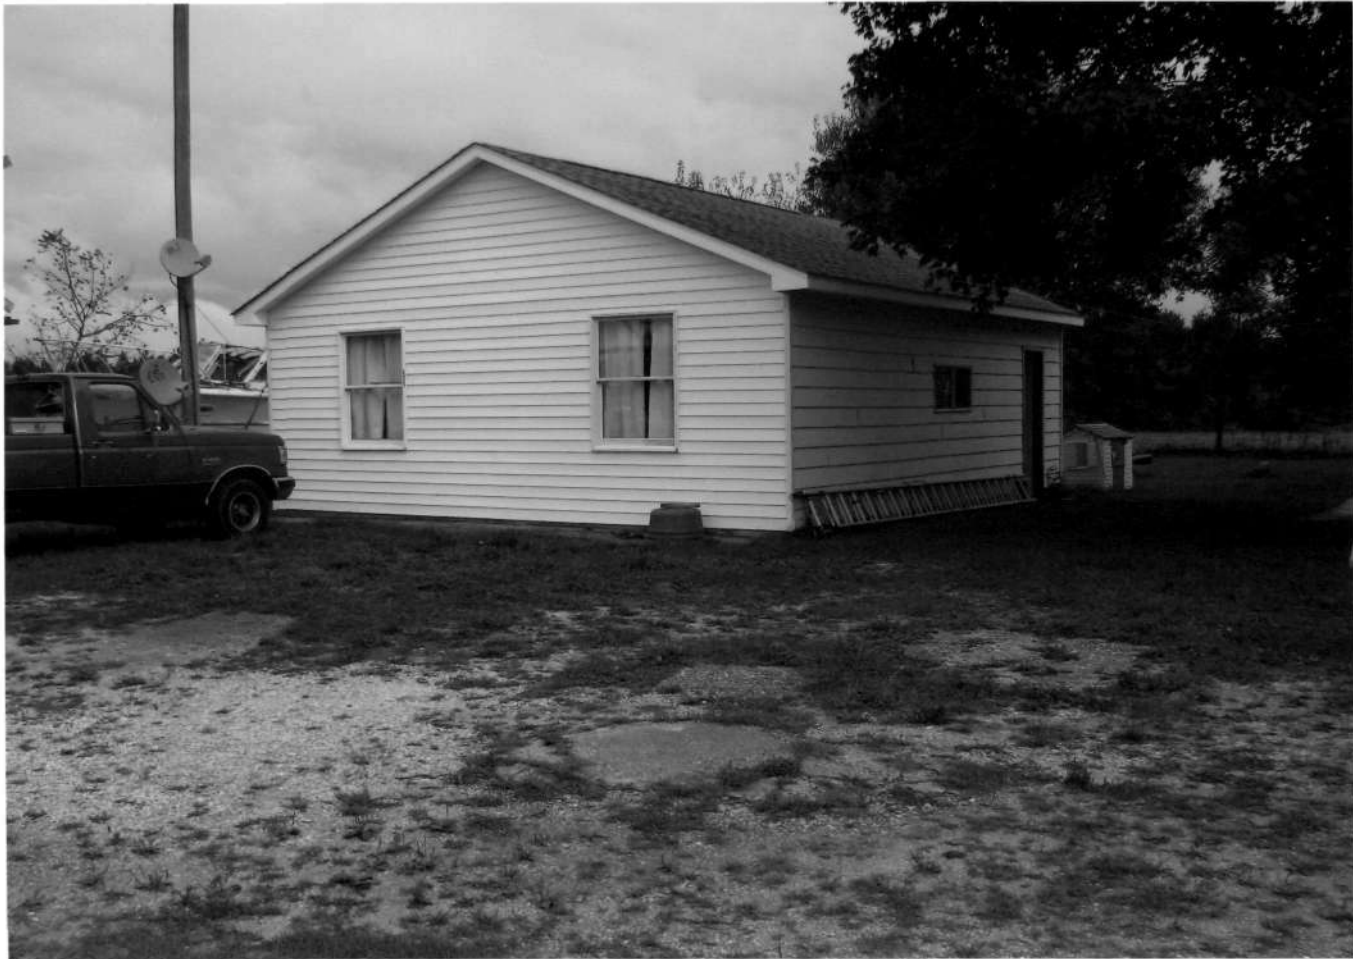
0024

VIEW OF FORMER GARAGE  
FROM THE WEST

Northwest of the kitchen wing is a rectangular frame building with low pitch asphalt roof that began life as a two-car garage about the same time as the kitchen wing, however the west doors were removed and replaced with a solid wall. It is now a work shop. It has two windows with 6/6-pane sash in place of the garage doors as well as a door on the east end of the south façade with small window next thereto. The walls are covered with aluminum siding.
